INSPECTION REPORT

For the Property at:
1 EXAMPLE AVENUE NW
CALGARY, AB

Prepared for: JOHN SMITH
Inspection Date: Monday, November 23, 2009
Prepared by: Alan Fisher, RHI

1 Example Avenue NW, Calgary, AB November 23, 2009

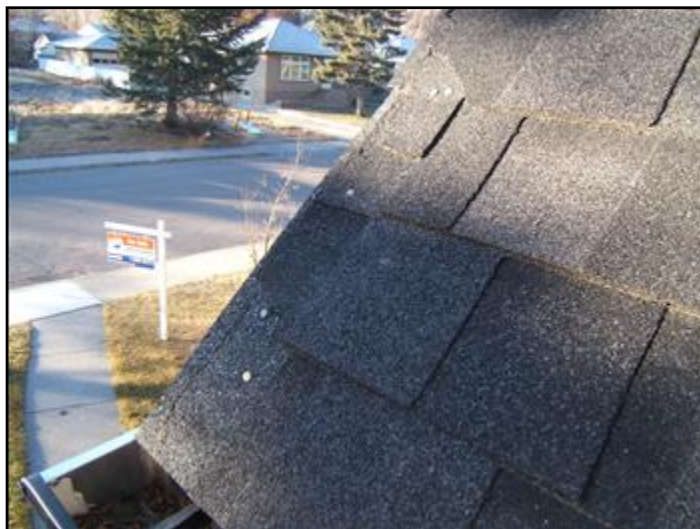
1.

Condition: • [Missing, loose or torn](#)

Implication(s): Chance of water damage to contents, finishes and/or structure

Location: Front

Task: Repair

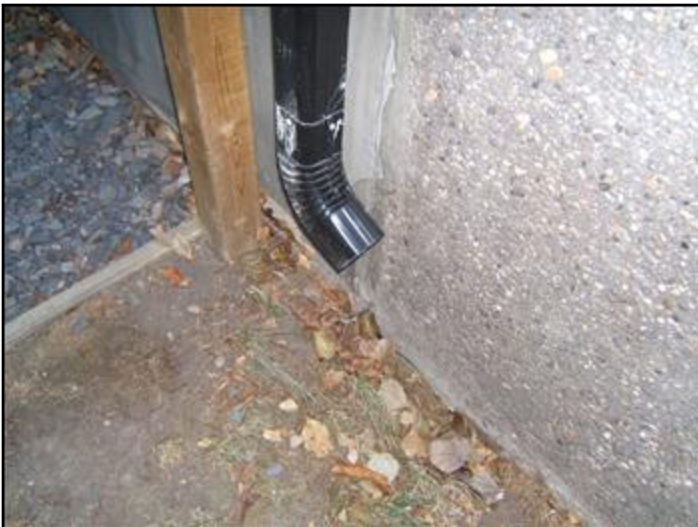
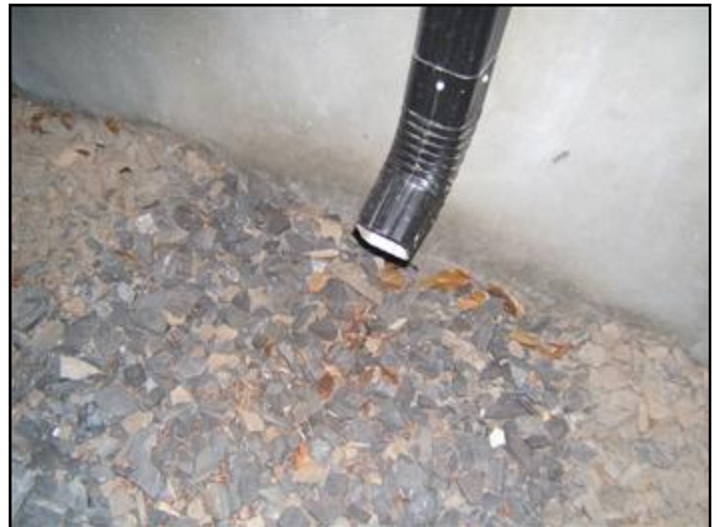
Condition: • [Downspouts end too close to building](#)

Implication(s): Chance of water damage to contents, finishes and/or structure

2. Typical

3. Typical

Task: Repair

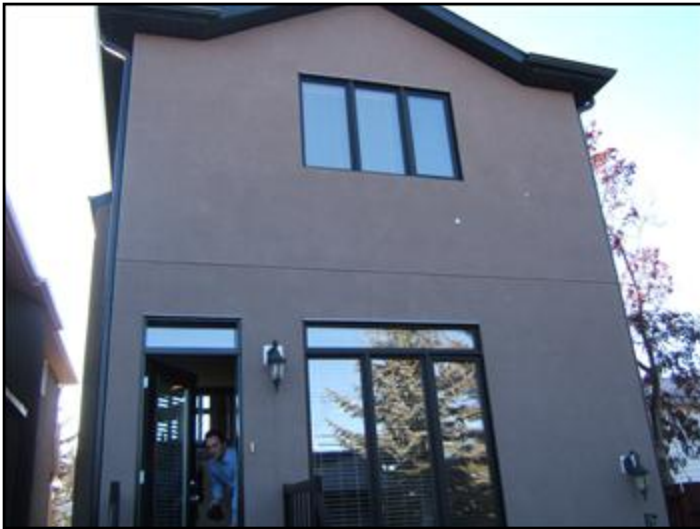
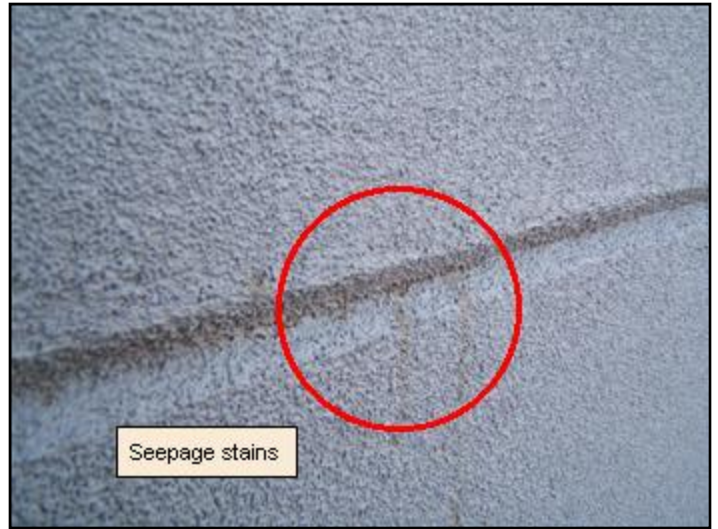
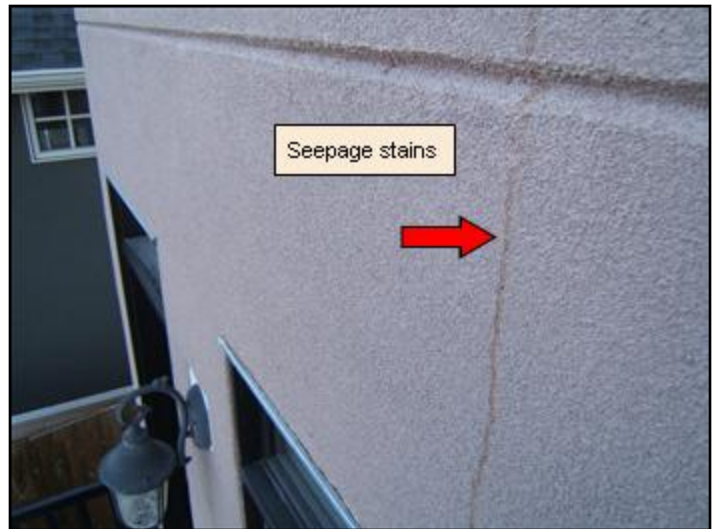
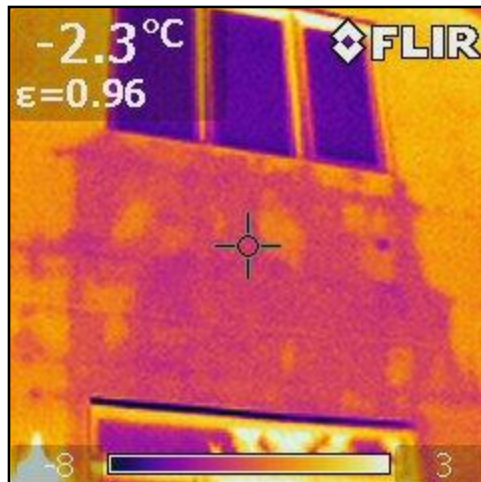
Condition: • [Moisture penetration](#)

Rear walls shows thermal anomalies. Stains at bottom of walls at parking may indicate condensation forming under Stucco/EIFS. Recommend further investigation by a stucco expert prior to removing purchase conditions.

Task: Further evaluation

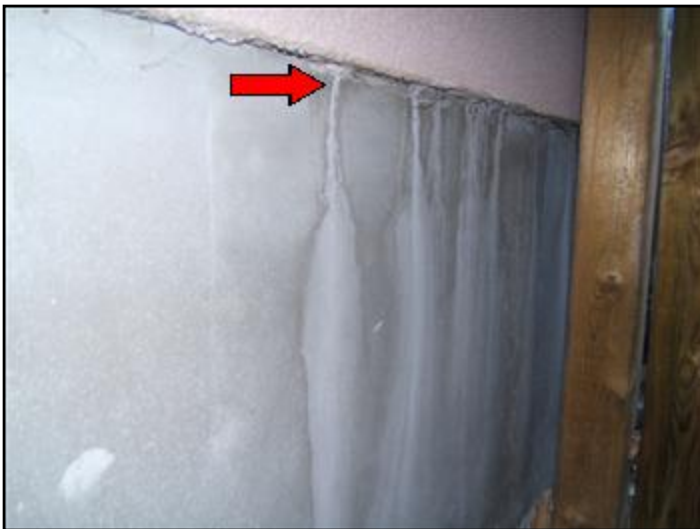
Implication(s): Chance of water damage to contents, finishes and/or structure | Material deterioration

6. Possible condensation stains

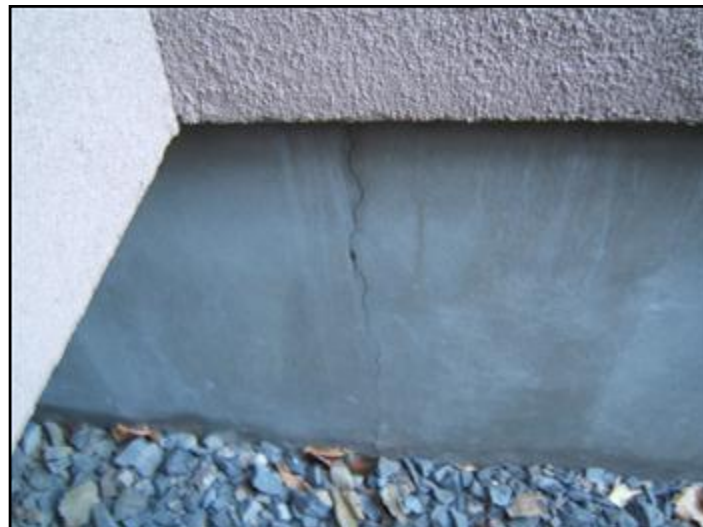
9.

- FOUNDATIONS \ Foundation**
- Condition:** • Typical minor cracks
- Location:** Basement
- Task:** Monitor

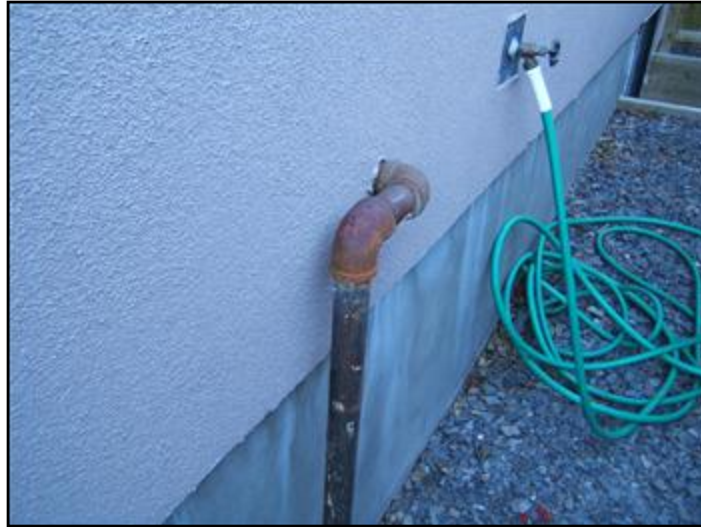
10.

Condition: • [Rust](#)

Paint required

Implication(s): Fire or explosion

Location: West Exterior

Task: Repair

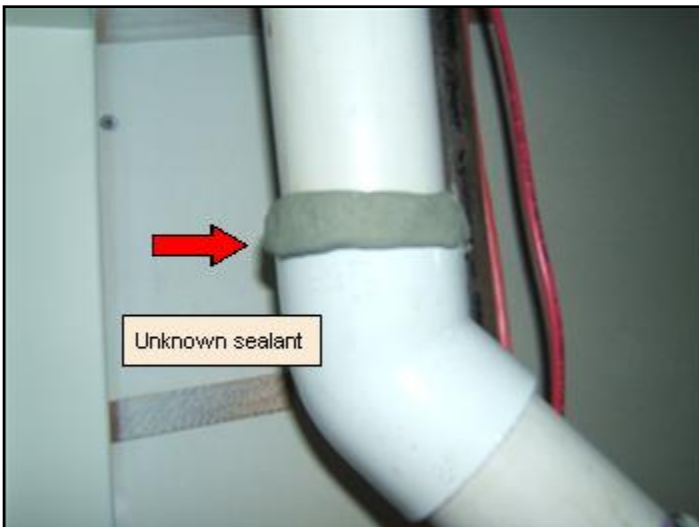
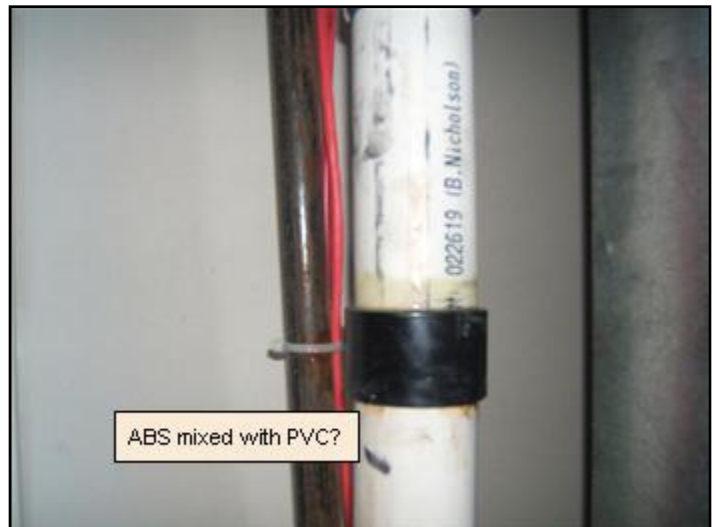
Condition: • [Improper material](#)

Implication(s): Equipment not operating properly | Hazardous combustion products entering home

Location: Basement Utility Room

Task: Repair

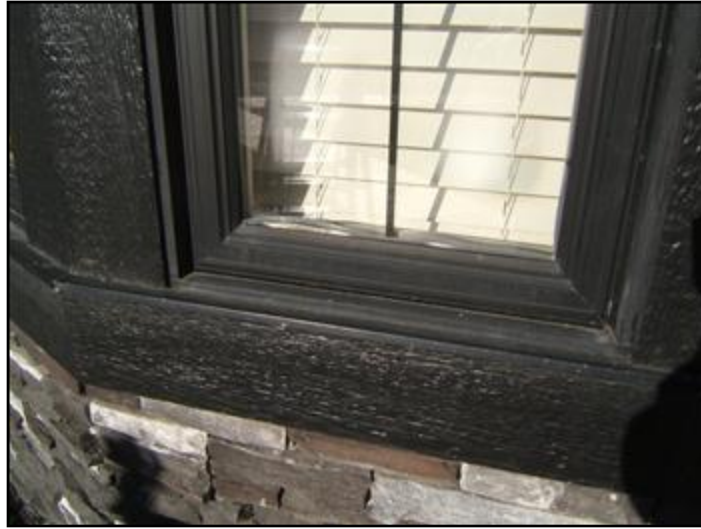
14.

WINDOWS \ Glass (glazing)
Condition: • [Lost seal on double or triple glazing](#)
Cracked glass
Implication(s): Cosmetic defects
Location: Front
Task: Replace
Time: Less than 1 year
