# Your Inspection Report

123 Any Crescent SE  
Calgary, AB

RE: Report No. 7152, v.2  
123 Any Crescent SE  
Calgary, AB

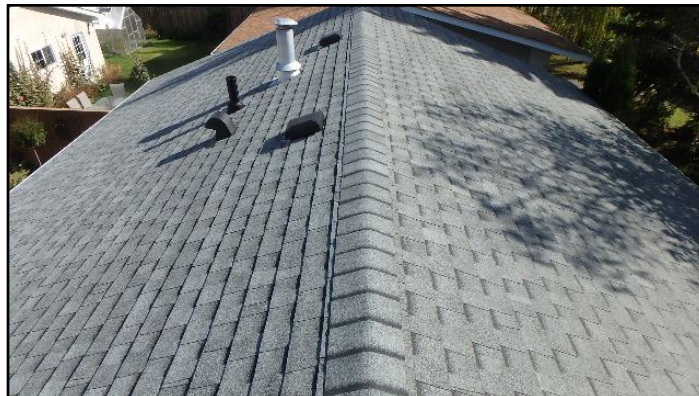
1. No roofing recommendations are offered as a...

**Condition:** • No roofing recommendations are offered as a result of this inspection.

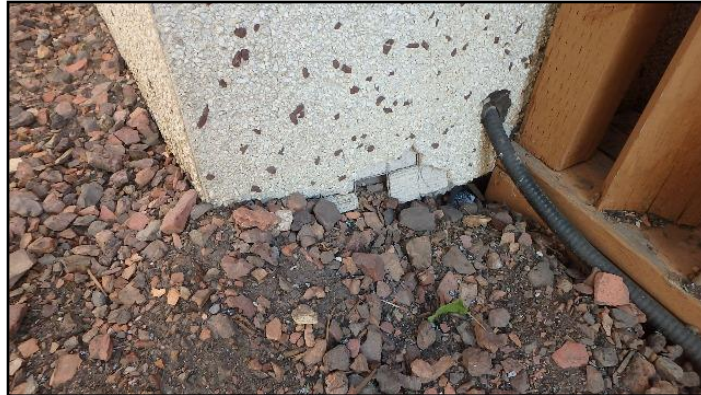
**Condition:** • [Too close to grade](#)

**Implication(s):** Chance of water damage to contents, finishes and/or structure | Material deterioration

2. Too close to grade

**Task:** Repair Improve

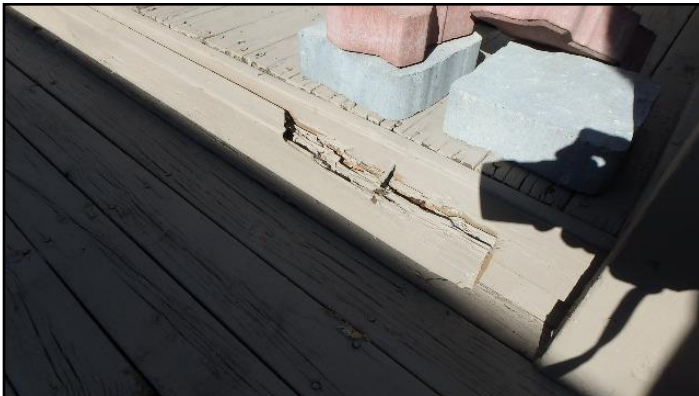
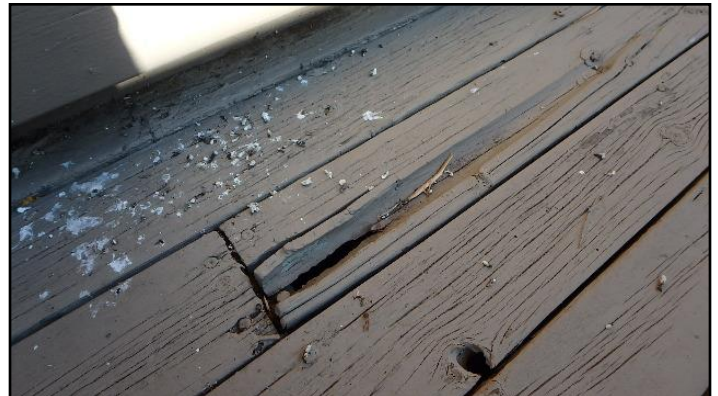
Condition: • [Rot](#)

3. Rot

4. Rot

Task: Repair

Time: Earliest opportunity

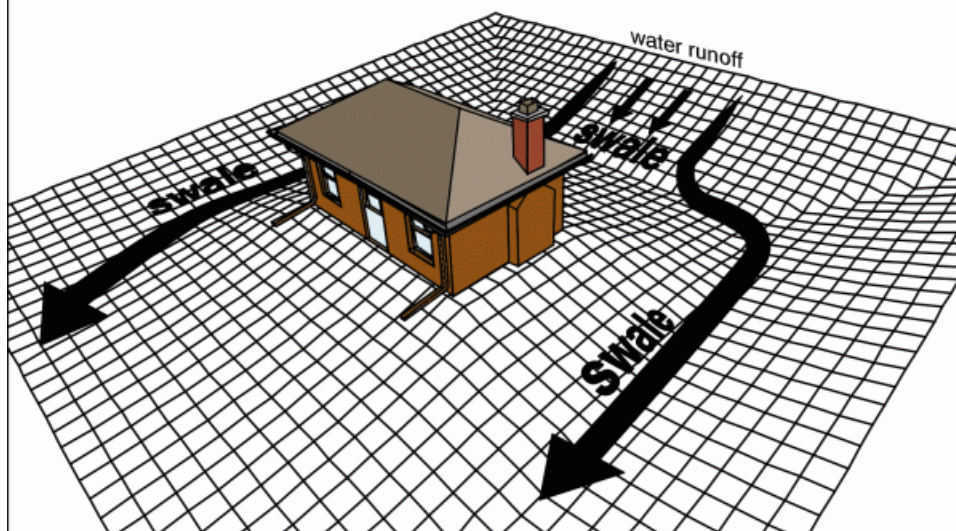
## Swales

when the overall lot drainage is toward the house, swales can be used to direct surface water away from the foundation

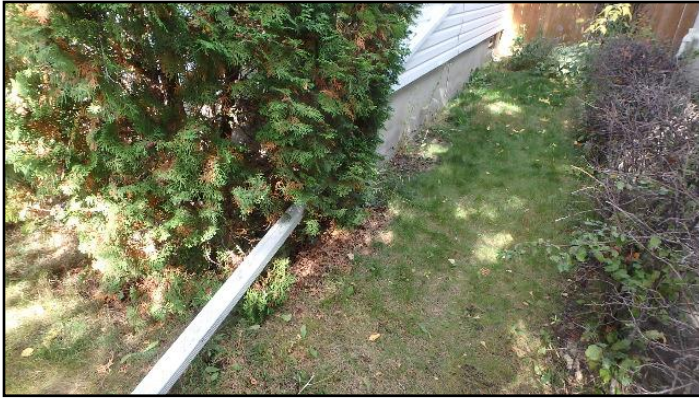
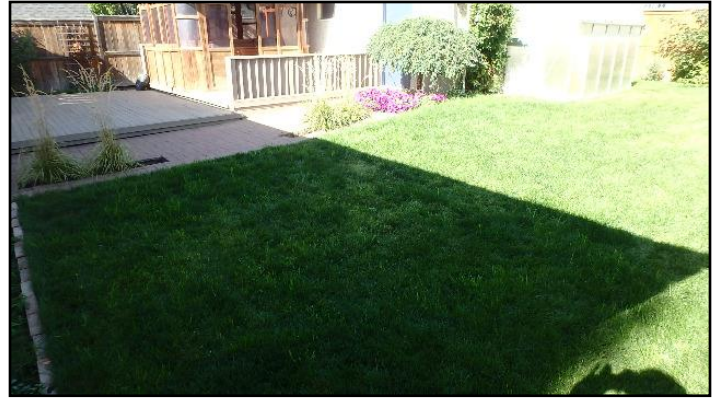
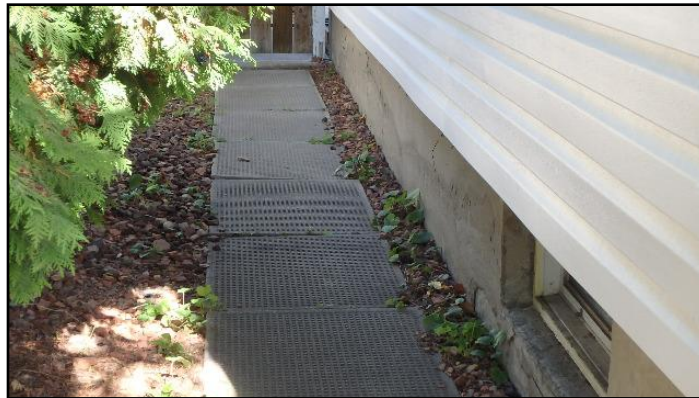
Condition: • [Improper slope or drainage](#)

Implication(s): Chance of water damage to contents, finishes and/or structure

5. Improper slope or drainage

6. Improper slope or drainage

7. Improper slope or drainage

• Basement leakage is often caused by conditions on the exterior of the home. Basements are not built like boats, and if water is allowed to collect outside of foundation walls, it will leak through into the basement. It is important that lot grading around the house slope down away from the building so that surface water from rain and melting snow is directed away from the building, rather than toward the foundation. This note is included as a general maintenance reminder to check and correct (if required) the grading on an annual basis.

• Basement leakage is often caused by conditions on the exterior of the home. It is important that gutters and downspouts collect roof water and carry it away from the house. Maintain proper drainage by ensuring downspouts discharge water well away from the foundation wall.

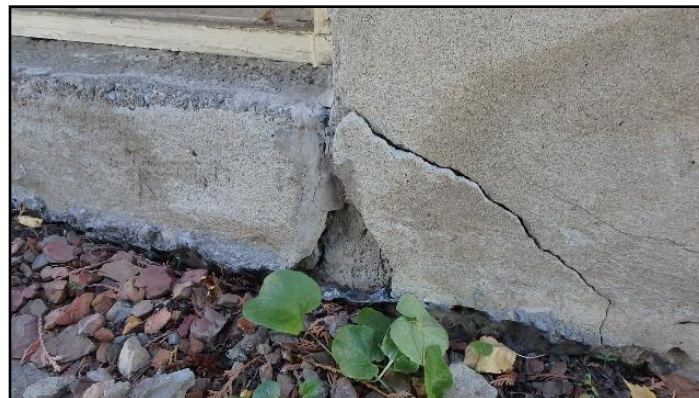
**Condition:** • [Cracked](#)

Stains noted

**Implication(s):** Chance of water damage to contents, finishes and/or structure | Weakened structure

8. Cracked

**Task:** Repair

**Time:** Immediate

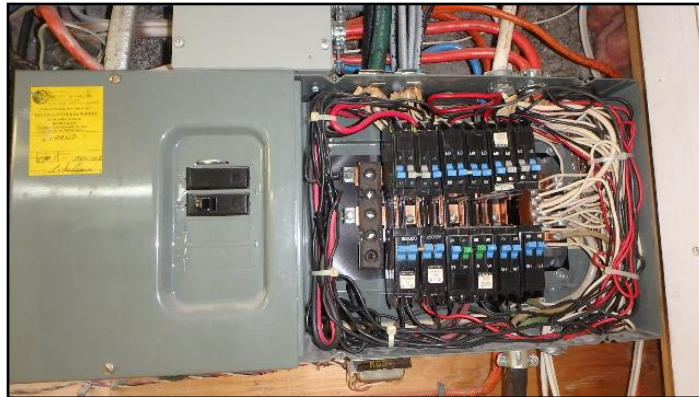
**Condition:** • [Crowded](#)

**Implication(s):** Electric shock | Fire hazard

9. Crowded

**Task:** Replace Upgrade

**Time:** When remodelling

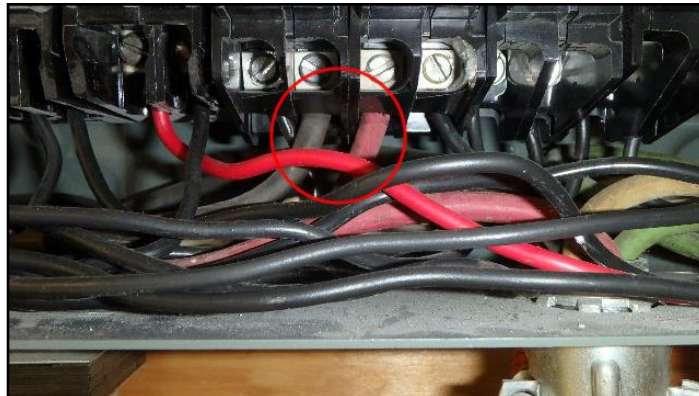
10.

**Condition:** • Improper wire type for dryer circuit

**Task:** Replace

**Time:** Earliest opportunity

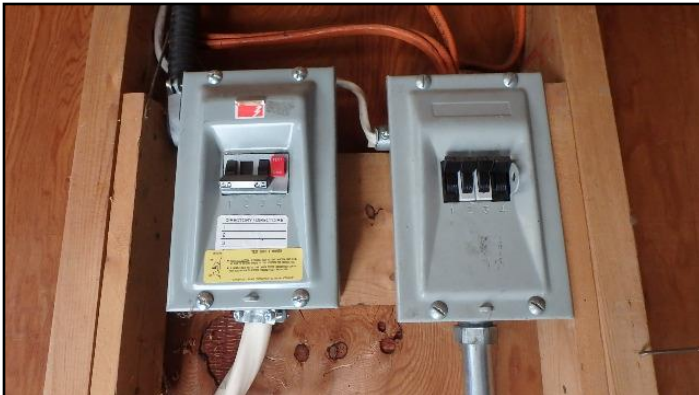
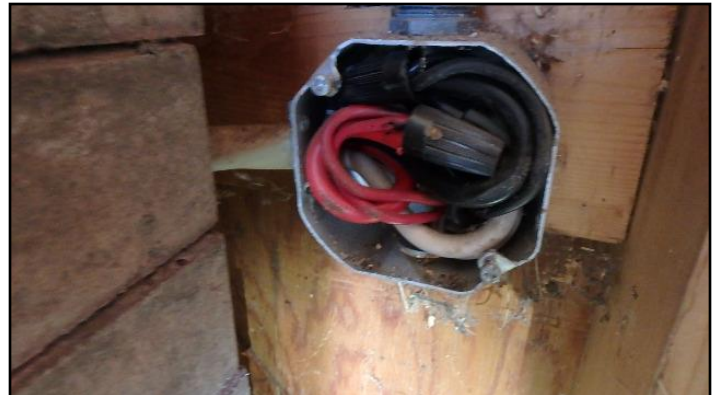
11.

**Condition:** • Garage service needs to be reviewed and corrected as necessary. Spa GFCI is tapped off main line to the garage prior to sub panel. Total capacity of the circuit may be exceeded.

**Task:** Repair Improve

**Time:** As necessary

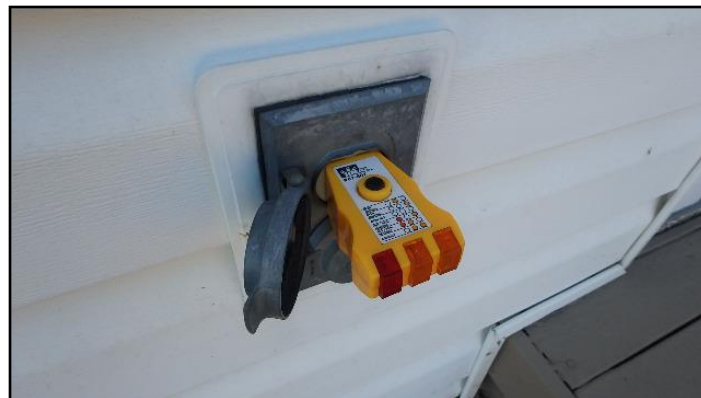
**Condition:** • Ground Fault Circuit (GFCI) protection not present at kitchen receptacles. GFCIs are required in newer homes for outlets near sinks etc. Although not required in older homes when they were built, it is an upgrade that can provide an added level of safety. Consult an electrician for complete details and other considerations.

**Condition:** • Ground Fault Circuit (GFCI) protection not present at exterior receptacles. GFCIs are required in newer homes for outlets. Although not required in older homes when they were built, it is an upgrade that can provide an added level of safety and should be considered.

13. No Ground Fault Circuit (GFCI)

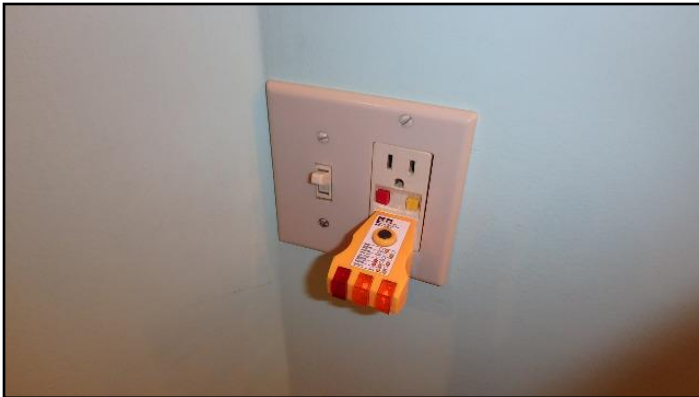
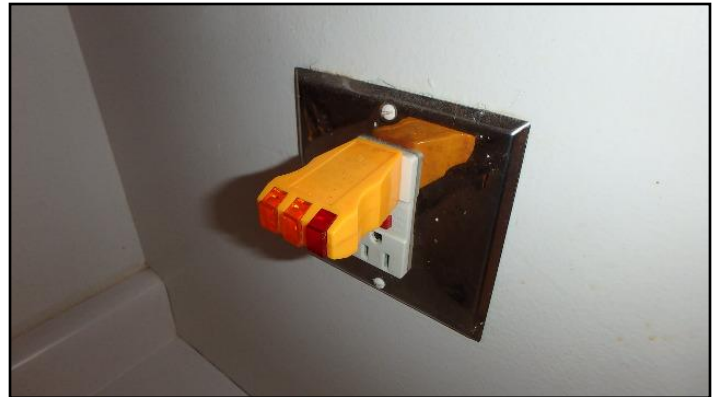
**Condition:** • [Test faulty on GFCI/GFI \(Ground Fault Circuit Interrupter\)](#)

14. Test faulty on GFCI/GFI (Ground Fault..

15. Test faulty on GFCI/GFI (Ground Fault..

**Task:** Replace

**Time:** Immediate

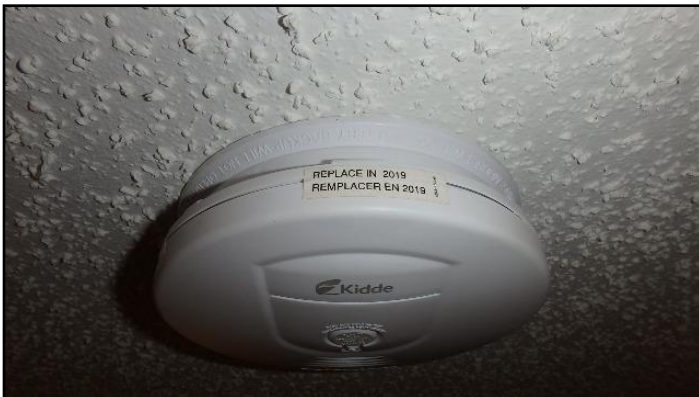
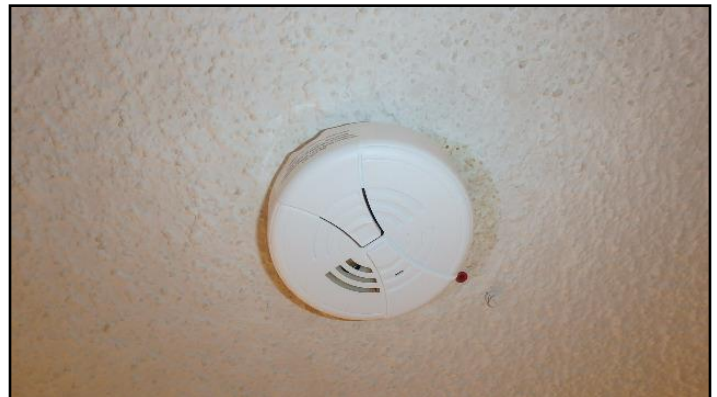
**Condition:** • More than 10 years old

**Implication(s):** Life safety hazard

16. More than 10 years old

17. More than 10 years old

**Task:** Replace / Upgrade

**Time:** Immediate

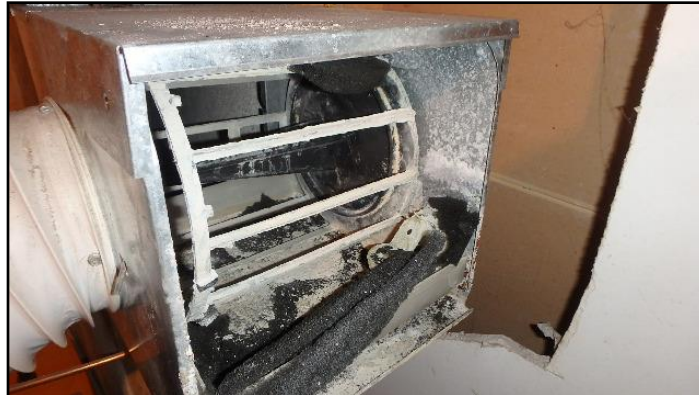
**Condition:** • Inoperative / out of service

18. *Inoperative / out of service*

**Task:** Replace

**Time:** Discretionary

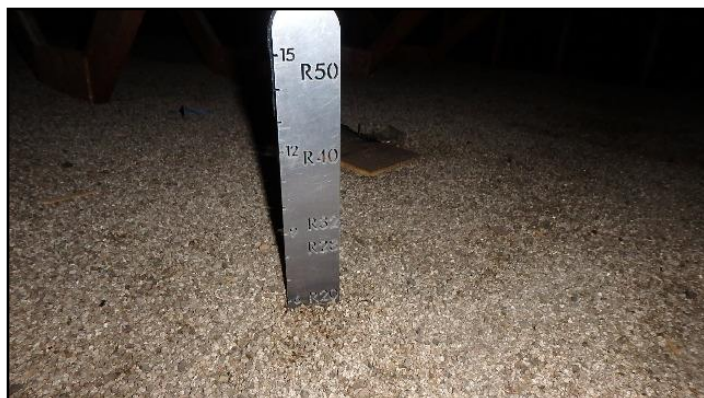
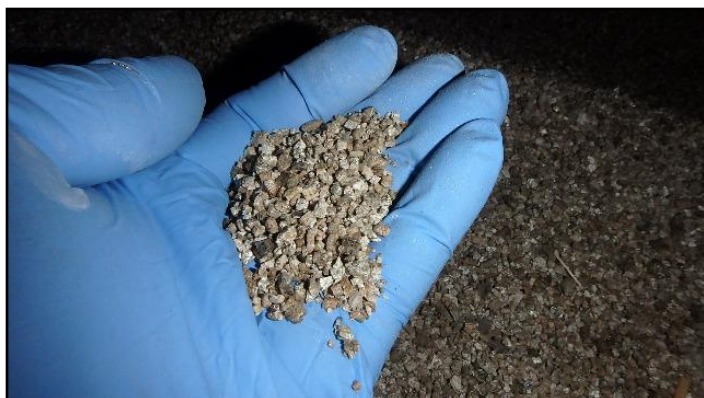
**Condition:** • [Possible Zonolite](#)

19. Possible Zonolite

20. Possible Zonolite

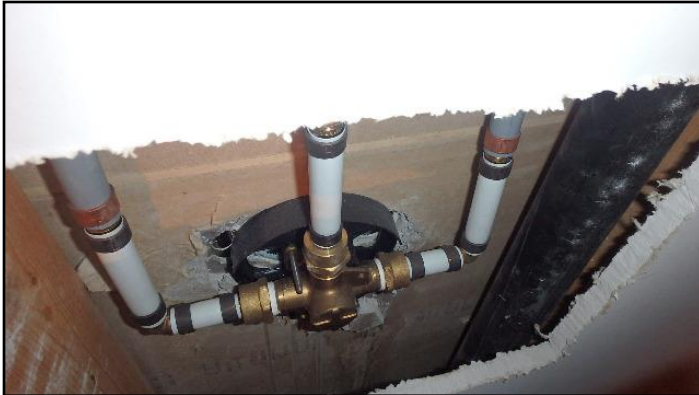
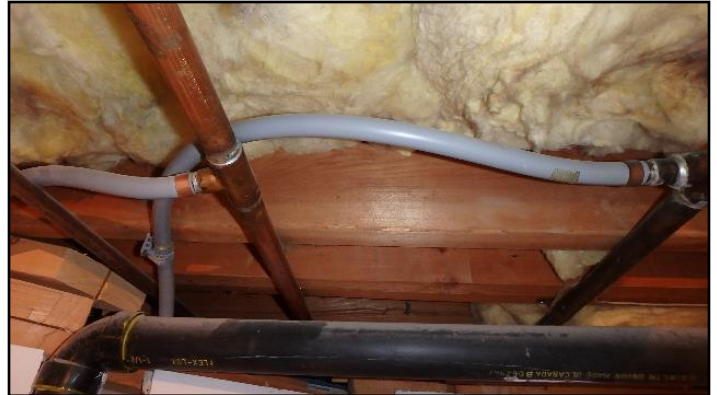
**Condition:** • [Polybutylene](#)

**Implication(s):** Chance of water damage to contents, finishes and/or structure | Leakage

21. Polybutylene

22. Polybutylene

**Task:** Replace

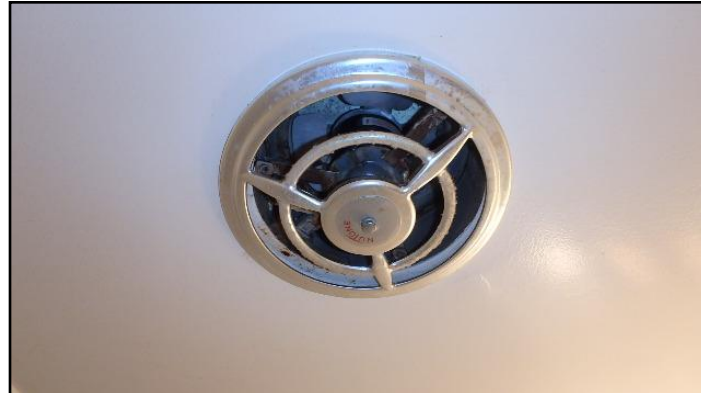
**Condition:** • [Noisy](#)

**Implication(s):** Reduced system life expectancy | Equipment failure

23. Noisy

**Task:** Replace

**Time:** Earliest opportunity

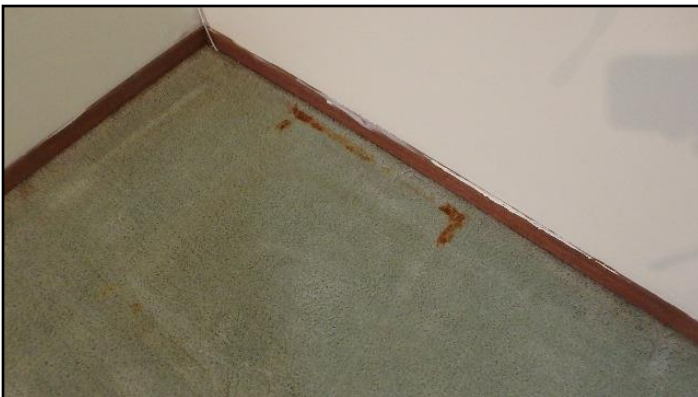
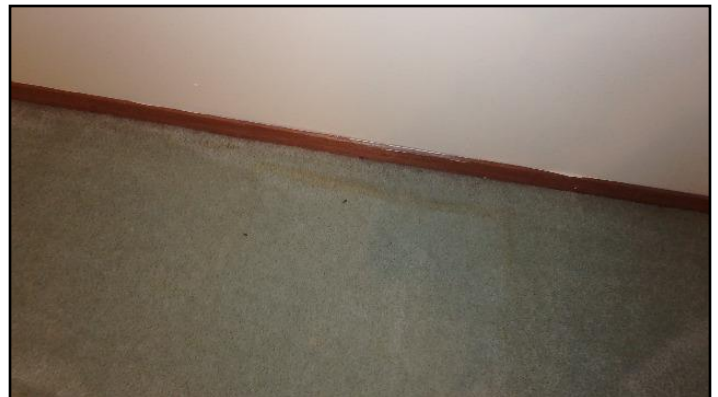
**Condition:** • [Rust](#)

Stains/rust on basement flooring. See exterior section for grading and drainage. Structure section for foundation crack.

**Implication(s):** Chance of water damage to contents, finishes and/or structure | Material deterioration

24. Rust

25. Rust

**Task:** Repair

**Time:** As necessary
